US Army Corps
of Engineers®

Coastal Barrier Island Breaching, Part 2: Mechanical Breaching and Breach Closure

by Ty V. Wamsley and Nicholas C. Kraus

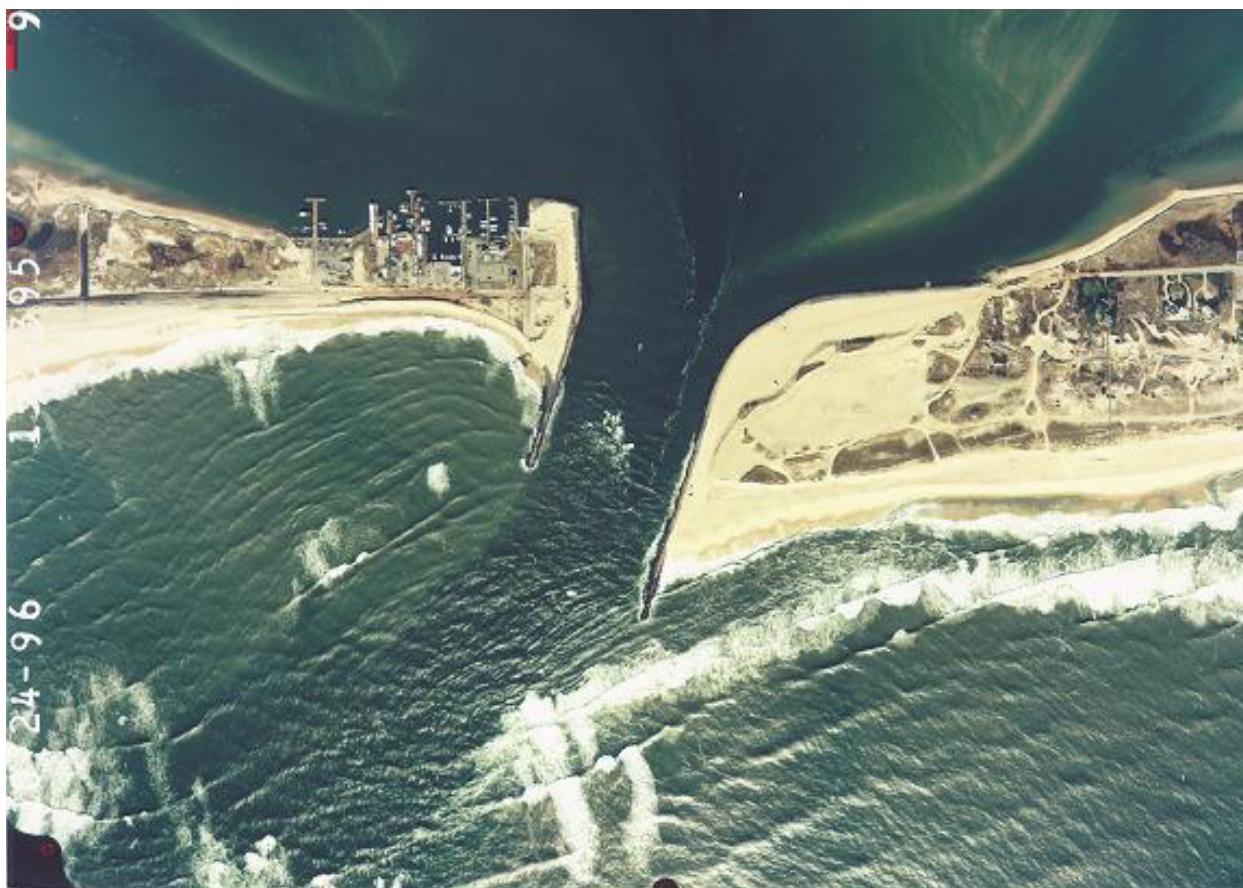
Figure 1 shows Shinnecock Inlet in October 1996, with the western beach (left side of jetties) eroded to endanger the public road and the marina complex on the north (bay) side of the barrier island. Emergency measures have been taken by the county and town during severe storms to prevent breaching. The U.S. Army Engineer District, New York, places material dredged from the Federal channel onto the eroding beach segment as a least-cost disposal alternative.

Figure 1. Shinnecock Inlet, NY, showing severely eroded downdrift beach adjacent to downdrift jetty

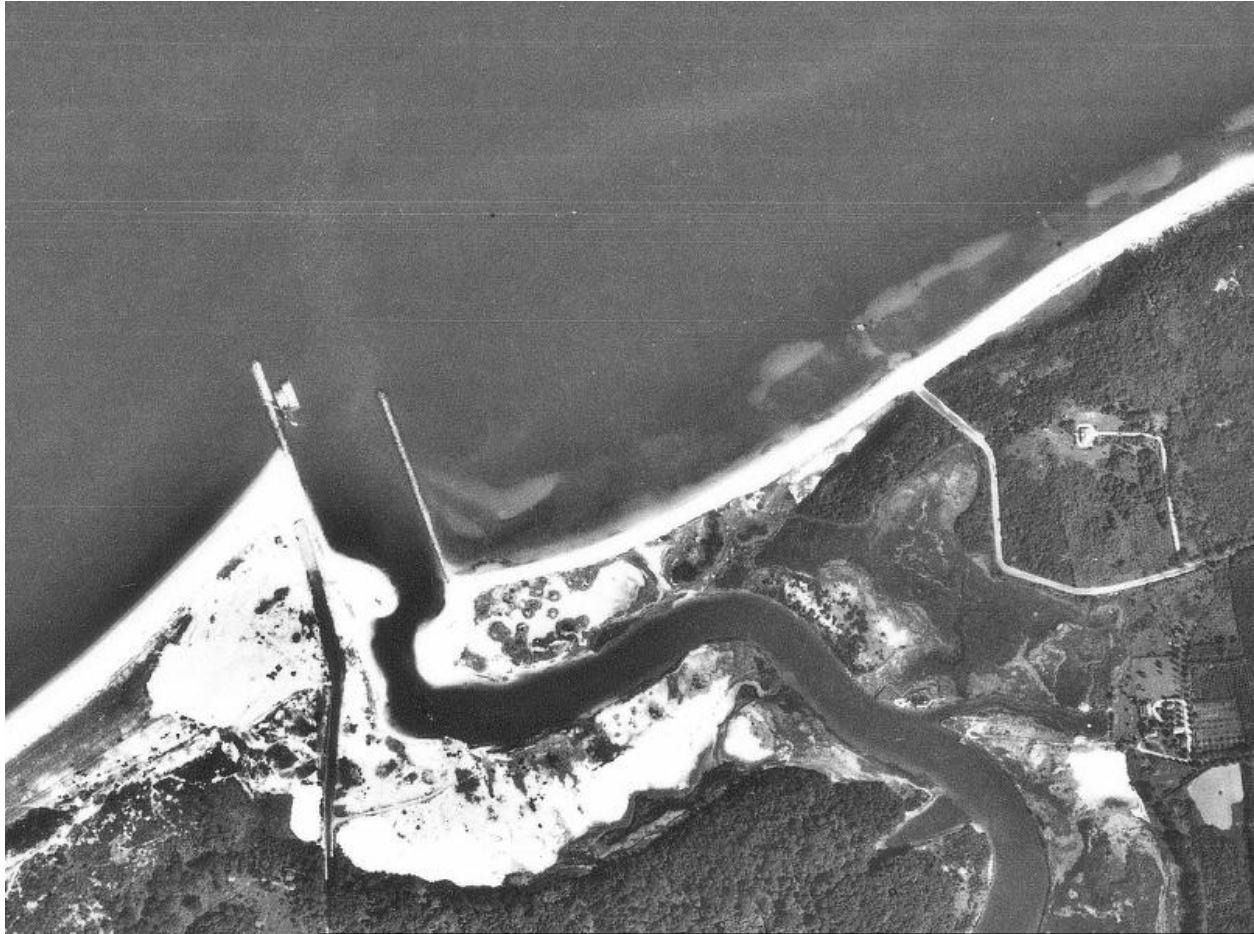
As another example, a downdrift breach occurred at Mattituck Inlet, Long Island, NY, which faces the Long Island Sound. Regional net transport is from west to east on this coast. The Federal jetties at Mattituck were constructed in the early 1900s. The shoreline directly east of Mattituck Inlet receded rapidly during the 1920s and 1930s, and a landward breach at the base of the east jetty at Mattituck Inlet opened in or around 1935, resulting in the formation of a west-directed spit (Figure 2) at the base of the east jetty that protruded into the navigation channel. In response to the breach, the New York District extended the east jetty landward in 1946, and material dredged during this time was placed onto the beach directly east of the inlet, the first known beach nourishment for this location (Morgan et al. 2005).

Figure 2. Mattituck Inlet, NY, with a spit encroaching from east (from right side in photograph) through a breach in barrier island

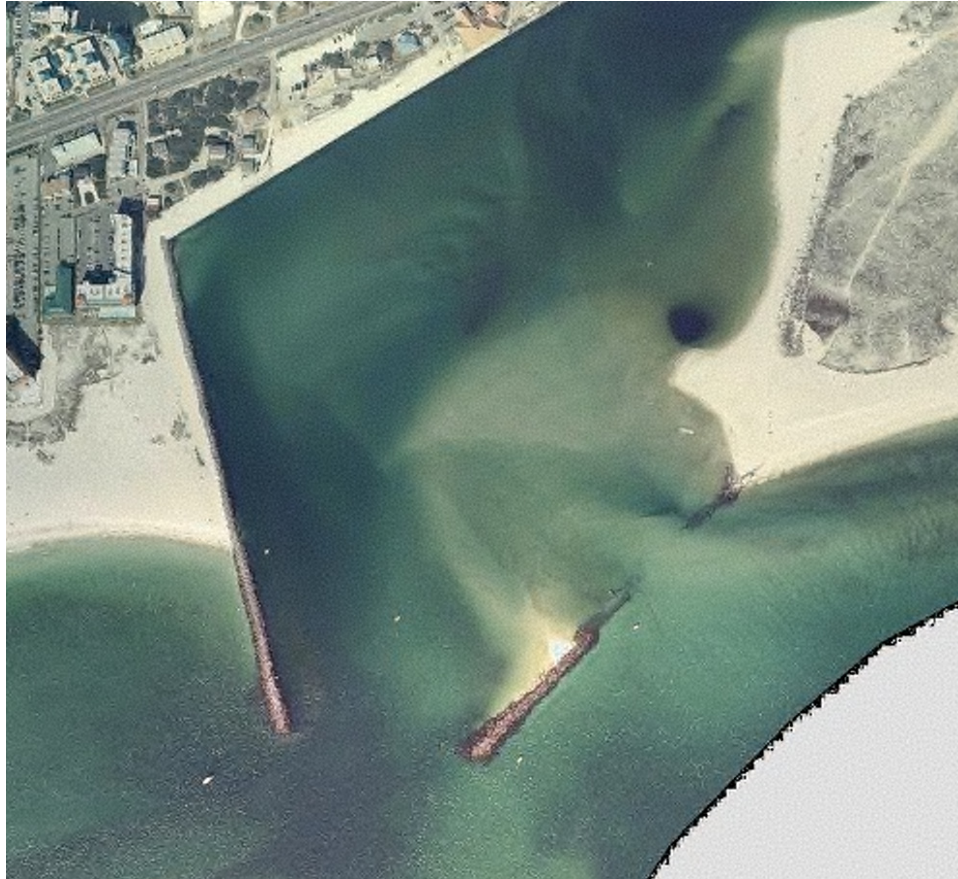
Perdido Pass, FL, is an example of breaching that occurs on the updrift side of the inlet because the jetty does not extend sufficiently landward (Figure 3). The updrift (east) beach adjacent to the east jetty is monitored and filled by the U.S. Army Engineer District, Mobile, to prevent further opening of breaches that occasionally occur there, such as after 2004 Hurricane Ivan.

Figure 3. Perdido Pass, FL, February 2003, with spit on right side protruding into channel behind weir jetty

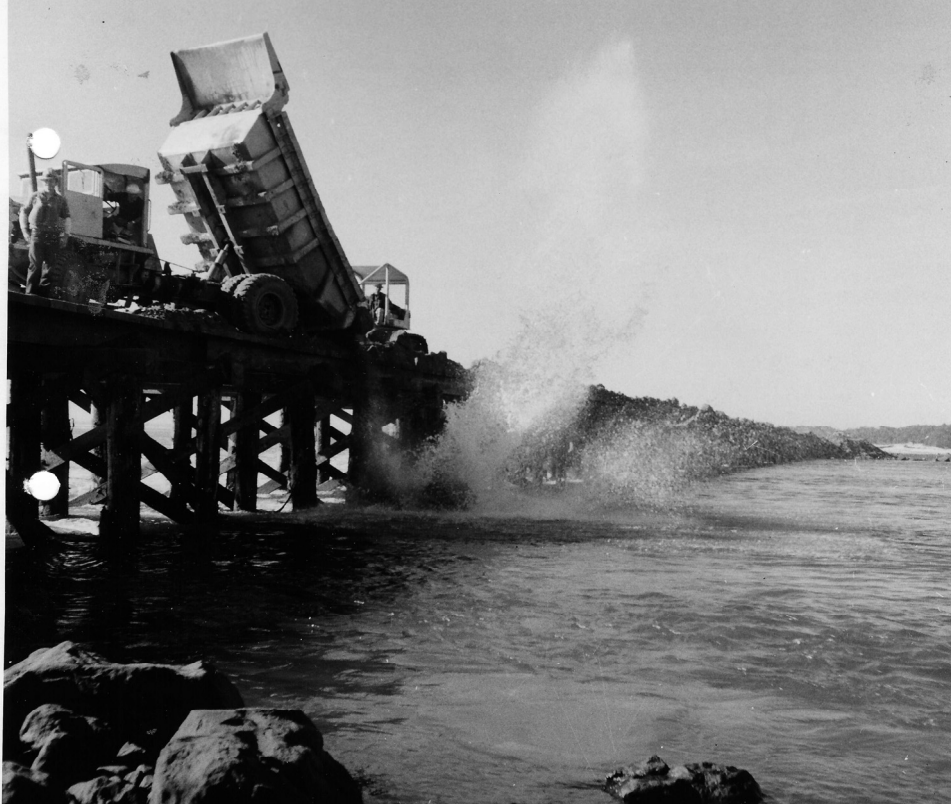
Figure 4. Rock fill by conventional end-dump method (Henshaw 1956)

The rock fill was placed across the breach channel from the mainland to the north wing spit. The first stone was placed in May of 1956. The rock fill was built with conventional end-dump methods (Figure 4). A dozer made the final placement of the rock. It had a top elevation of 6.1 m (20 ft) mllw and a top width of 4.6 m (15 ft). The side slopes were 1 on 1-1/2. Eighty percent of the rock on the

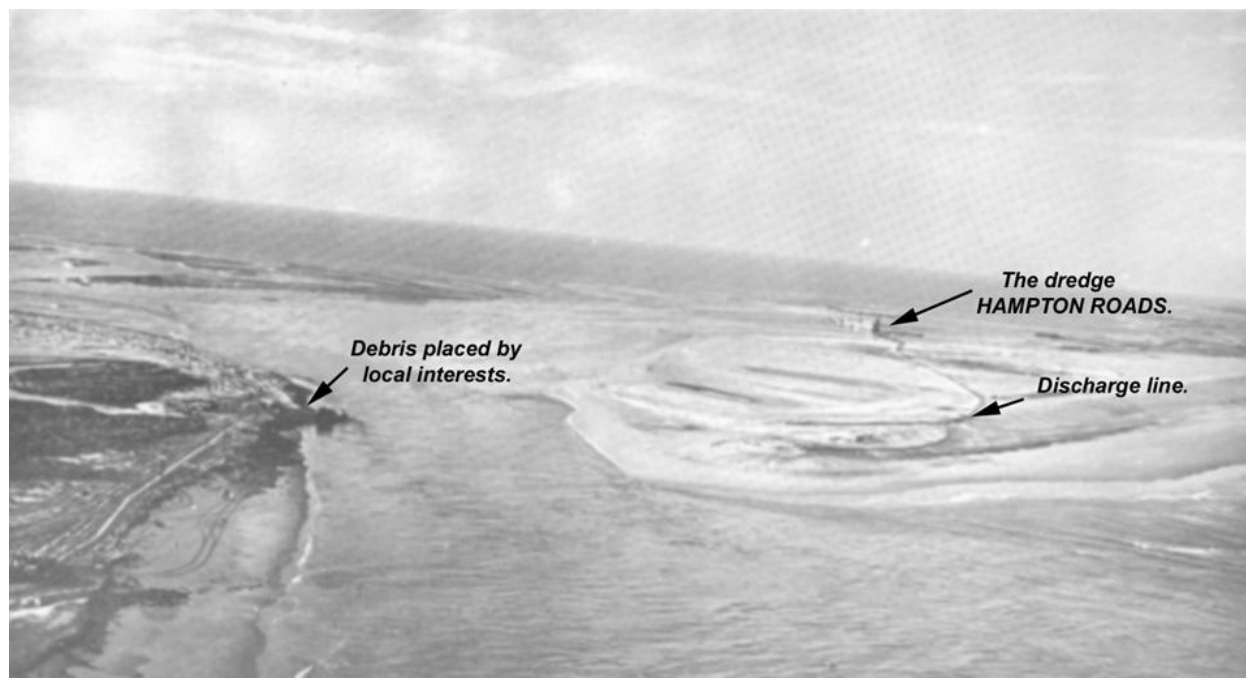
Figure 5. The Buxton breach, 29 January 1963, looking toward sound (Wilmington District 1963)

The Buxton Inlet experience taught that if a breach is to be closed by pumping alone, the pumping capacity must be sufficient to overcome scour as the breach closes. In addition, to reduce channel migration, the breach should be filled from both sides, or the bank opposite the fill operation should be revetted in some way.

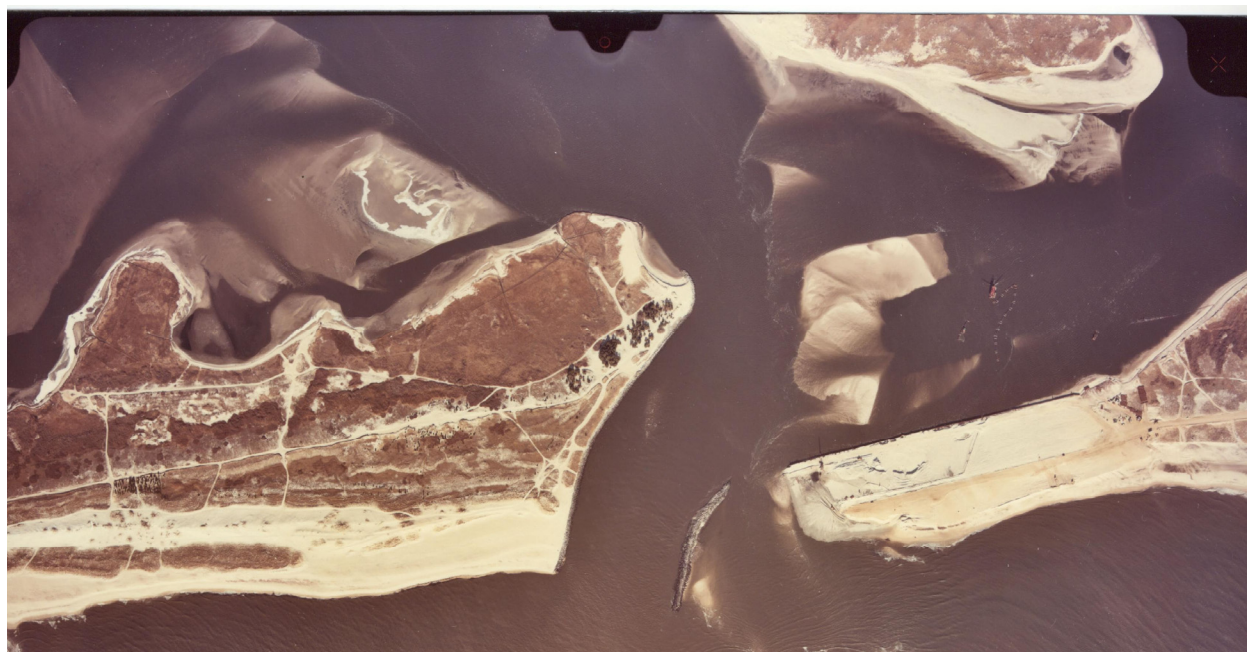
Figure 6. Moriches Inlet breach fill construction nearing completion, 4 December 1980

The method selected for the breach fill included construction of two temporary sheet-pile walls 9.1 m (30 ft) apart and parallel along the bay side of the breach. The initial option of placing the sand with no temporary retaining structures was discarded because of the potential for a high loss of fill material as the operation was to take place during the winter storm season. In addition to minimizing

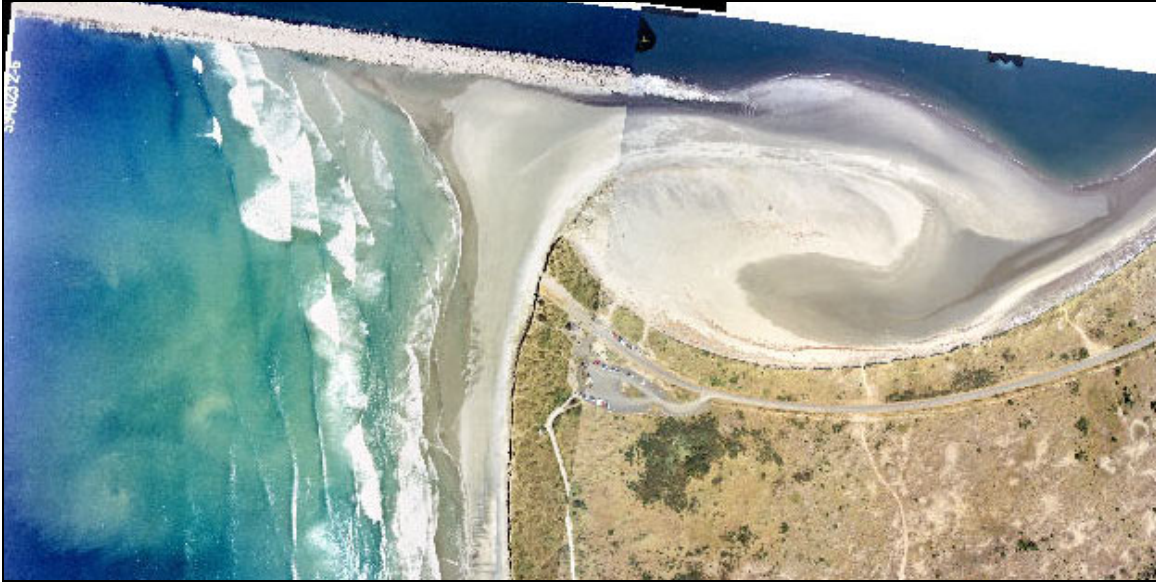
In December 1993, the persistent erosion on both the ocean and bay sides of the south spit at Grays Harbor culminated in formation of a breach between the south jetty and the adjacent beach. The breach widened rapidly, exposing the landward end of the jetty and eroding portions of the adjacent state park. Within hours of breach formation, the width was estimated by visual observation to be approximately 7.6 m (25 ft). Approximately 1 week later, aerial photographs show the breach had widened to approximately 83.8 m (275 ft). The breach reached a maximum width of approximately 165 m (540 ft) before it was mechanically filled by the U.S. Army Engineer District, Seattle, in the fall of 1994 (Wamsley et al. 2005).

a. Before closure, August 1994

Figure 7. Grays Harbor, WA, breach area

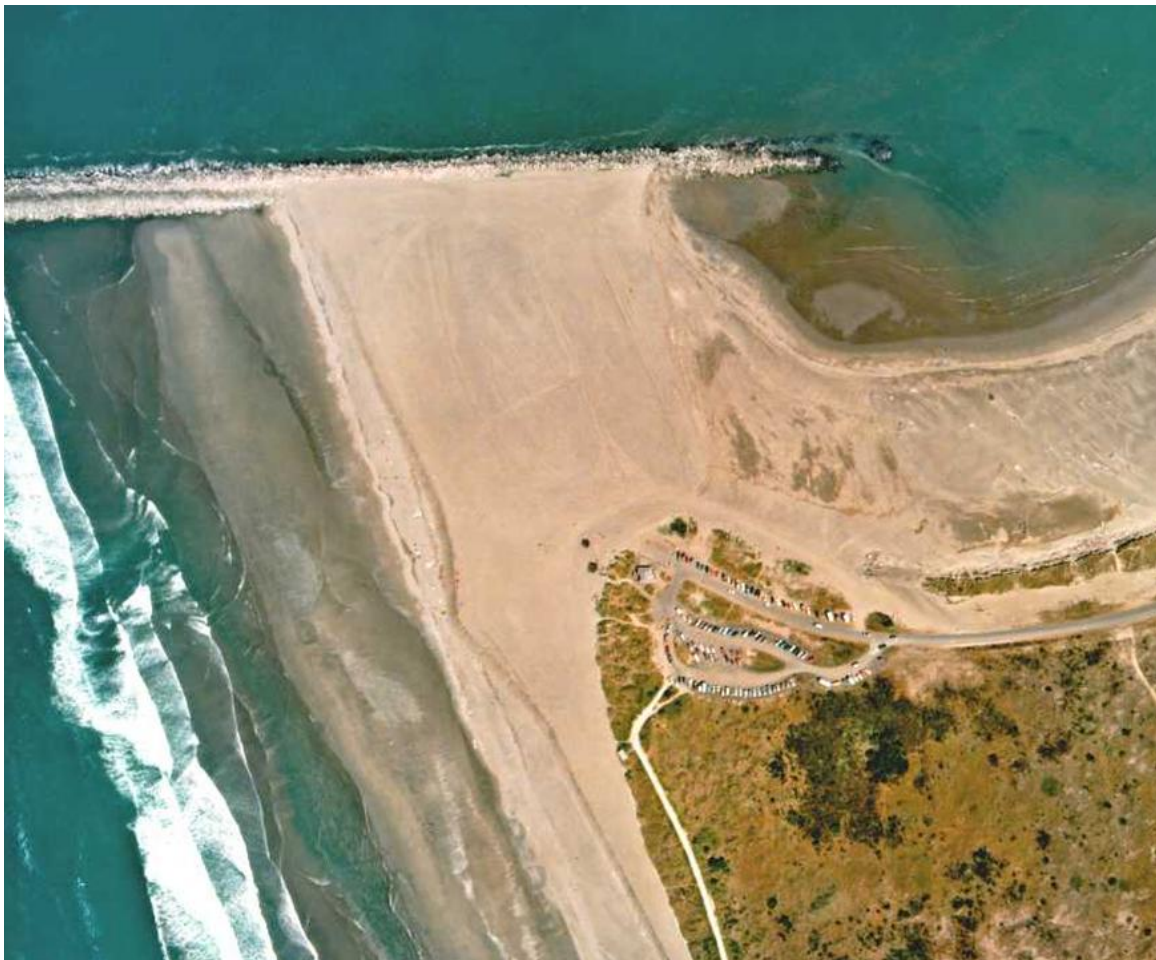
b. After closure, September 1995. Closure was completed in December 1994

The sand was pumped unconfined on the upland adjacent to the breach and stockpiled until a sufficient volume was available to close the breach. The breach was closed by bulldozing the stockpiled material into the narrowest part of the breach. The closure operation began around low tide, and the initial closure was completed by high tide. The sand was pushed from the beach, across the breach toward the jetty. Maximum current velocity through the breach at the time of closure was about 2 m (6.5 ft) per sec, but there was little flow through the breach at low tide. With the initial fill cross section in place, the same technique was applied to complete the fill to the final design template. The breach fill was completed on 7 December 1994 with 458,732.9 cu m (600,000 cu yd) of sand dredged from the navigation channel. Photographs in Figure 7 show the breach area before and after closure.

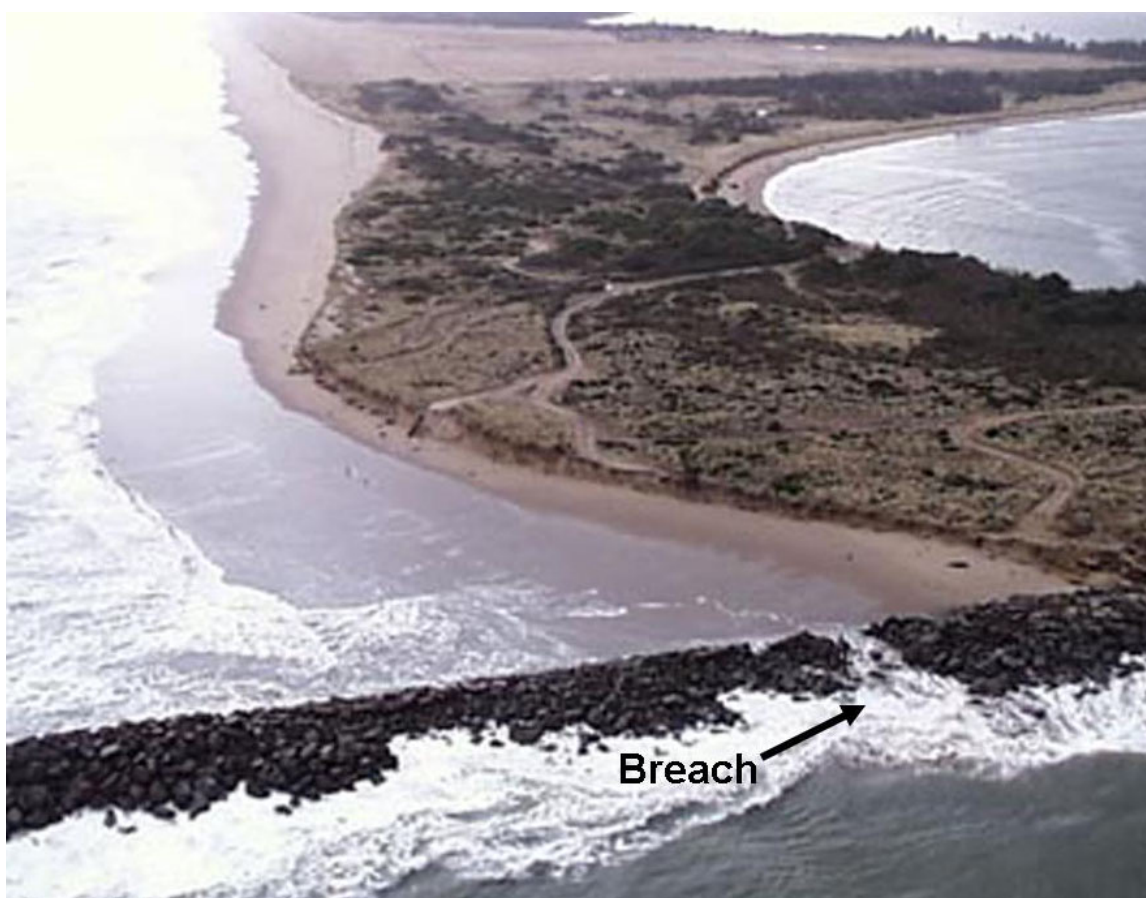
Figure 8. Coos Bay, OR, breach of north jetty (Hays et al. 2003)

Following the breach, the beach adjacent to the north jetty eroded, losing an estimated 30,582.1 cu m (40,000 cu yd) of sand through the breach and into the entrance. The beach profile elevation was lowered approximately 75 m (6.5 ft). Tidal flow through the breach widened the damaged area in the weeks following the storm. Approximately 40 days after the jetty breached, the opening had widened from an initial 4-m (13-ft) width to about 245 ft. The jetty breach caused rapid shoreline recession and, if not closed, could have resulted in a breach of the barrier spit.

Because of the continued damage to the jetty and the transport of sediment through the jetty and into the navigation channel, the U.S. Army Engineer District, Portland, initiated the coordination of an emergency repair on 25 November 2002. Construction began on 20 December 2002, and the repair was completed on 9 January 2003. The jetty was restored to the 1939 design cross section with slightly larger stone to improve structure stability. A jetty “bench” was also constructed along the structure to protect the foundation from return flow scour. The bench is a rubble mound constructed perpendicular to the jetty on the beach side to an elevation of +3 m (+9.8 ft) mllw and 6.1 m (20 ft) wide. The jetty repair also included a 38,227.7-cu m- (50,000-cu yd-) sand fill in the eroded area adjacent to the jetty breach. The fill replaced the sand lost through the breach and advanced the shoreline seaward of the repair area. The fill buried the bench and provides protection to the jetty root. The jetty has not sustained damage since the repair.

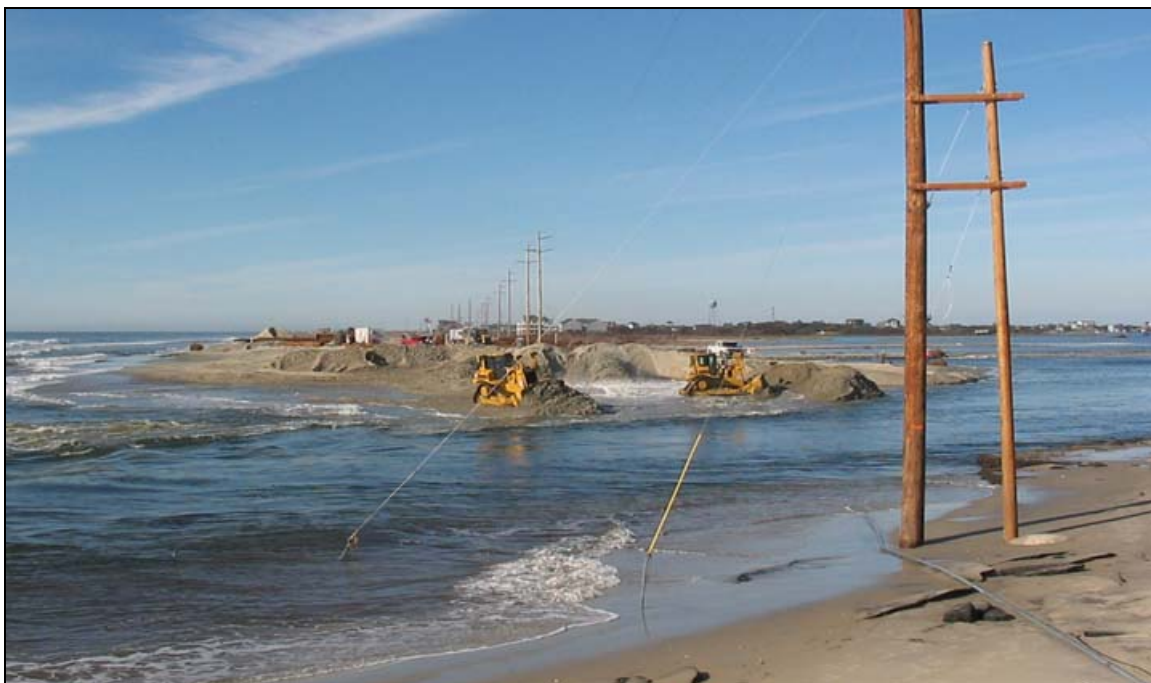
On 1 November 2003, approximately 30.5 m (100 ft) of the breach remained to be filled. Similar to Buxton Inlet, as the cross-sectional area of the breach was reduced, the current velocity increased and scoured much of the sand that was deposited, even with the large pumping capacity. To facilitate rapid advance of the fill and close the remaining portion of the breach, a narrow mound of sand was bulldozed across the breach at slack tide to prevent water flow through it (Figure 9). Once the flow of water was stopped, additional material was added to the narrow mound to fill the remaining design template without the losses caused by the tidal current. The final closure began at high tide and was completed at low tide, thus allowing several hours for the berm to be widened before wave runup began to erode the berm at higher water levels. No material was stockpiled in advance, but a 1,758.5 cu m (2,300 cu yd) per hour dredge production rate provided a sufficient source of sand to build a small dike across the remaining breach. It was observed that the final closure would have been facilitated by stockpiling sand on the bank opposite the dredge pipe outlet. The stockpile would have allowed sand to be pushed from both sides of the breach.

Figure 9. A view of first attempt to complete closure looking to west from eastern bank of breach (Wutkowski 2004)

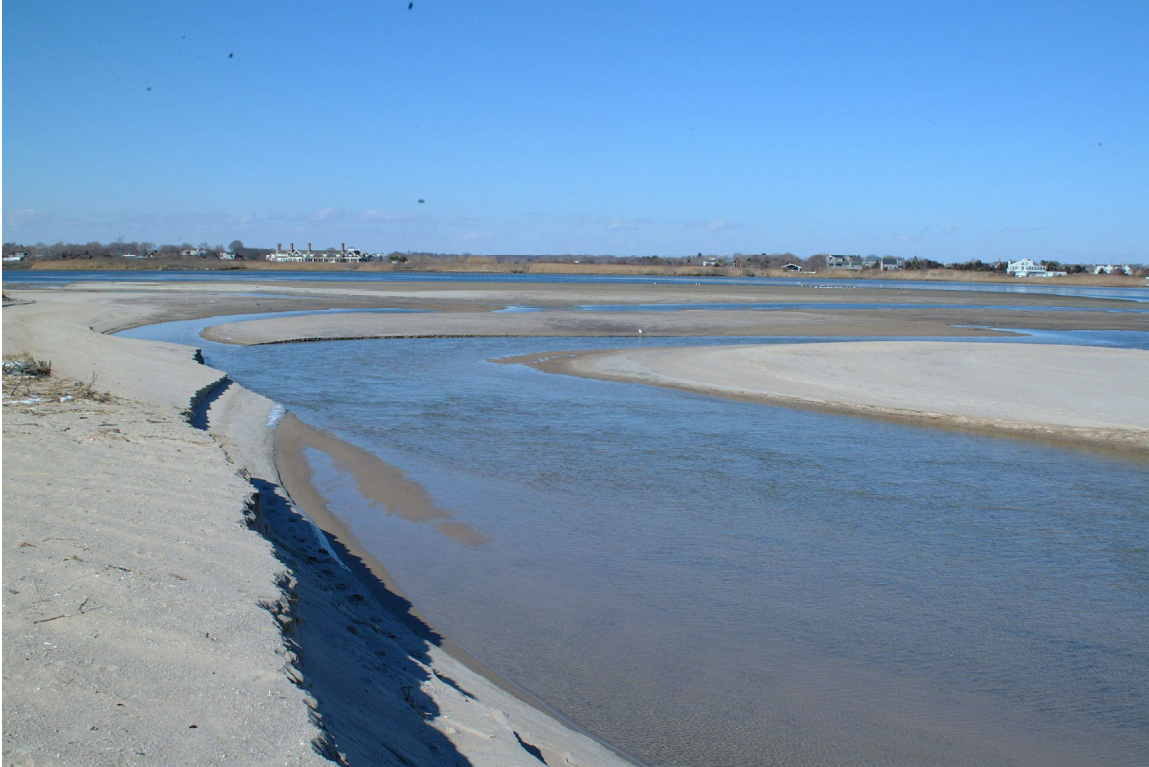
Figure 10. Breach cut at Sagaponak Pond on Long Island (looking toward pond), 4 March 2005
